# FACILITY CONDITION ASSESSMENT

*Barrington ES* | February 2022

Austin ISD - Barrington

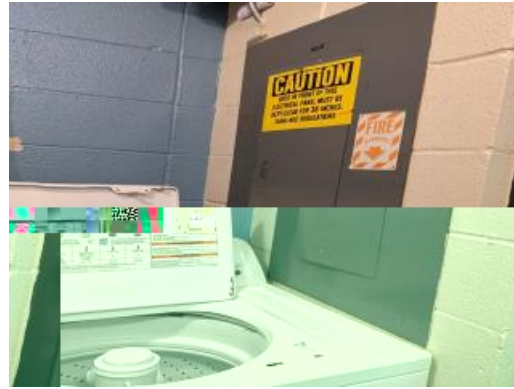
Obstructed electrical panel
