FACILITY CONDITION ASSESSMENT

Sunset Valley ES | February 2022

Austin ISD - Sunset Valley

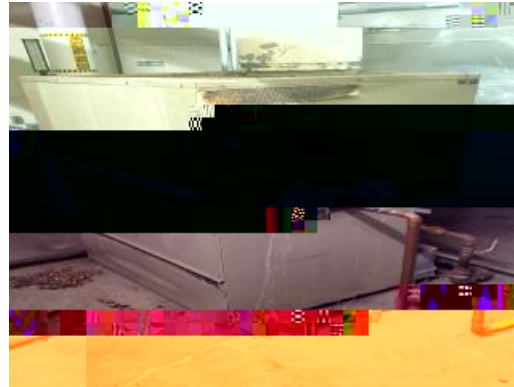
Ductwork is at end of life

Deficiency	Category	Qty	UoM	Priority	Repair Cost	ID
Ceiling Exhaust Fan Replacement	Capital Renewal	4	Ea.	4	\$1,947	2472
Ductwork Repair	Deferred Maintenance	20	LF	4	\$115	2379
Note: rust/exposed Location: gym						
	Sub Total for System	4	items		\$174,567
